Investigation Summary Report

2015-020: Benga Mining Limited, operating as Riversdale Resources

Coal Exploration Program Authorizations 130011, 140009

March 8, 2017

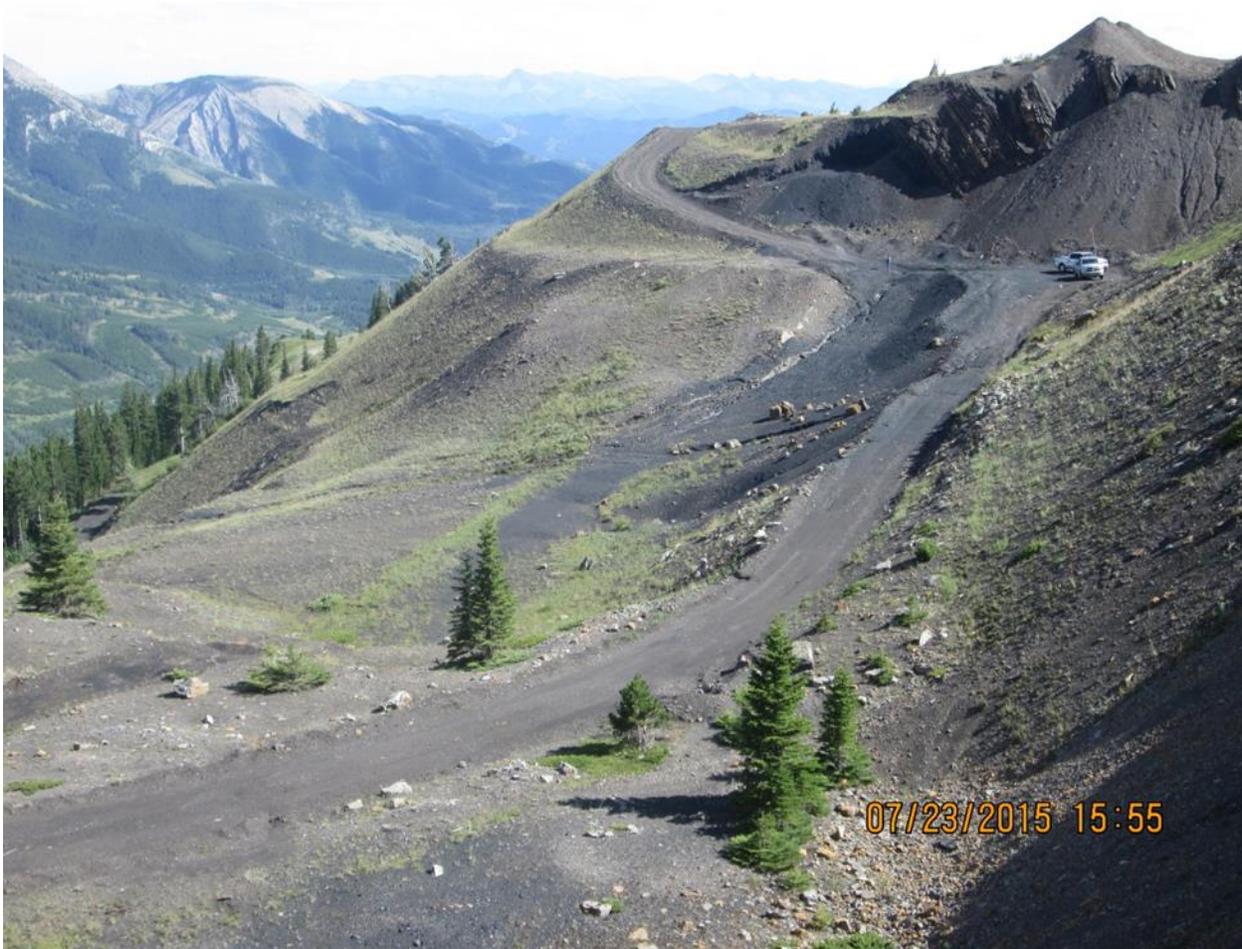
- The Benga Mining geologist said that the coal was part of a natural seam that had been exposed by mining when the mine was operating in the early 1960s.⁸

Figure 1. Source of coal on ROE 8751 (July 2015 from AER staff)

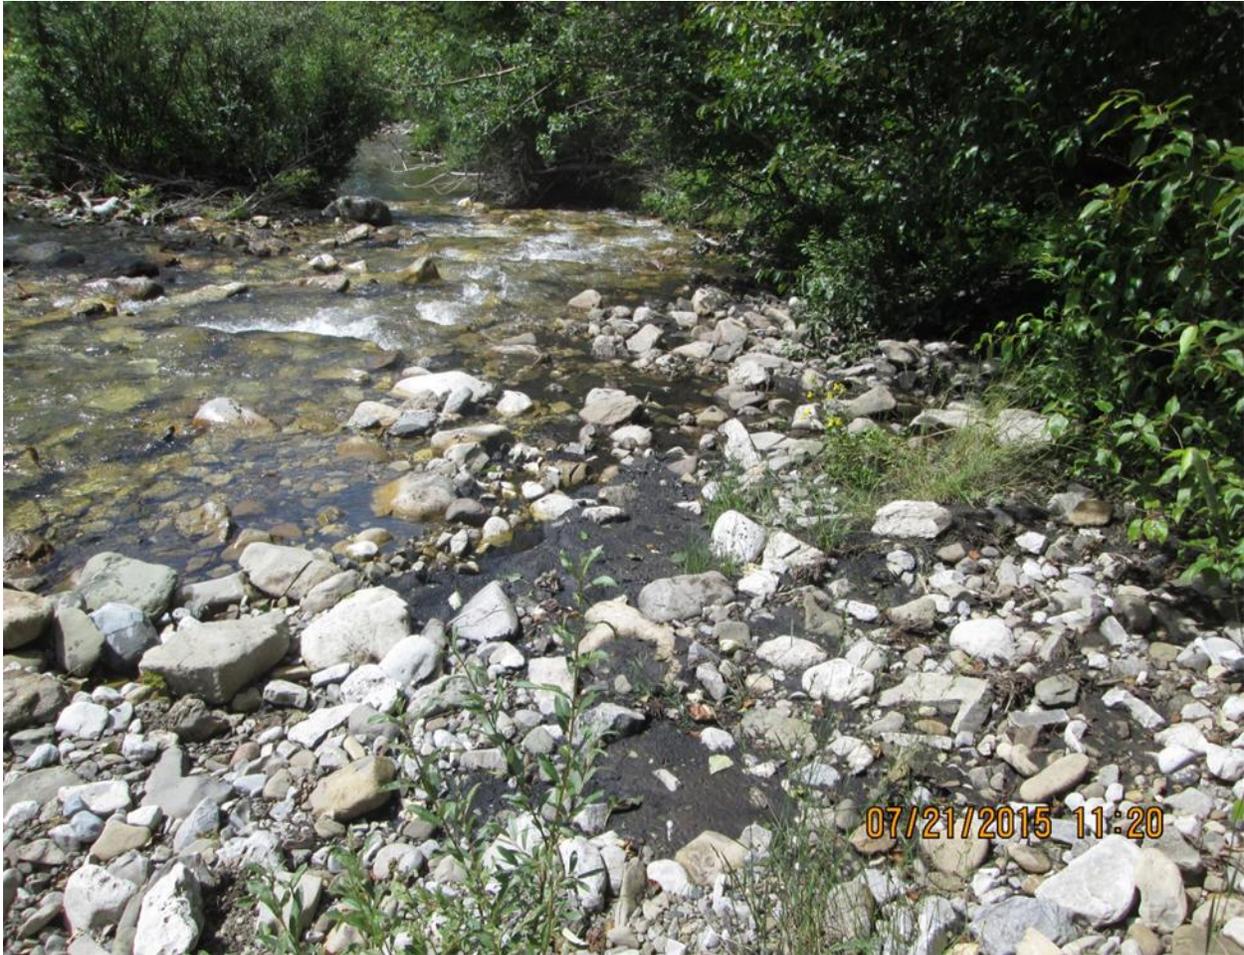
- The inspection of Gold Creek identified where the coal entered the creek from the tributary.⁹ How far the coal travelled down Gold Creek and the exact impacted area were not determined.

Figure 2. Tributary enters Gold Creek (point of entry of coal in Gold Creek); July 2015 from AER staff.

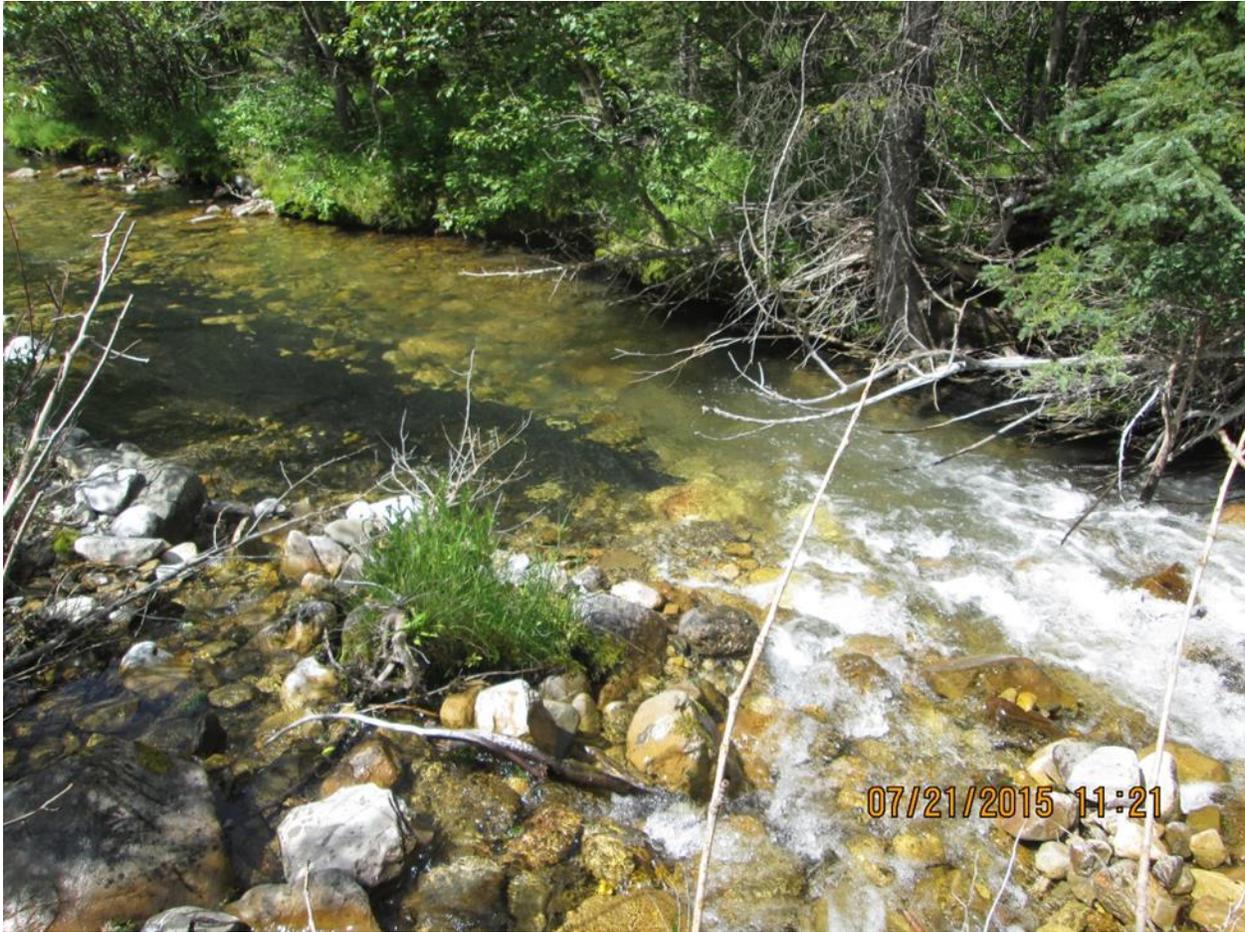
- An AER inspector, AEP investigator, and AEP fisheries biologist met with the public complainant and walked the section of Gold Creek where they noticed the coal deposits.⁶ During the inspection it was evident that coal fines were deposited into Gold Creek, and it was obviously the tributary that conveyed the coal.

- AER staff did check the Gold Creek Bridge at Hwy 3 near Frank, Alberta, and could not identify any coal deposit at that location. For about the 200 metres that was inspected where the tributary enters Gold Creek, the coal settled to the creek bed in natural areas of the creek—e.g., back eddies and pools—where water flows more slowly. Deposits were up to **6 inches deep**. Less coal was deposited between these locations.

Figure 3. Example of coal deposits in Gold Creek (July 2015 from AER staff)

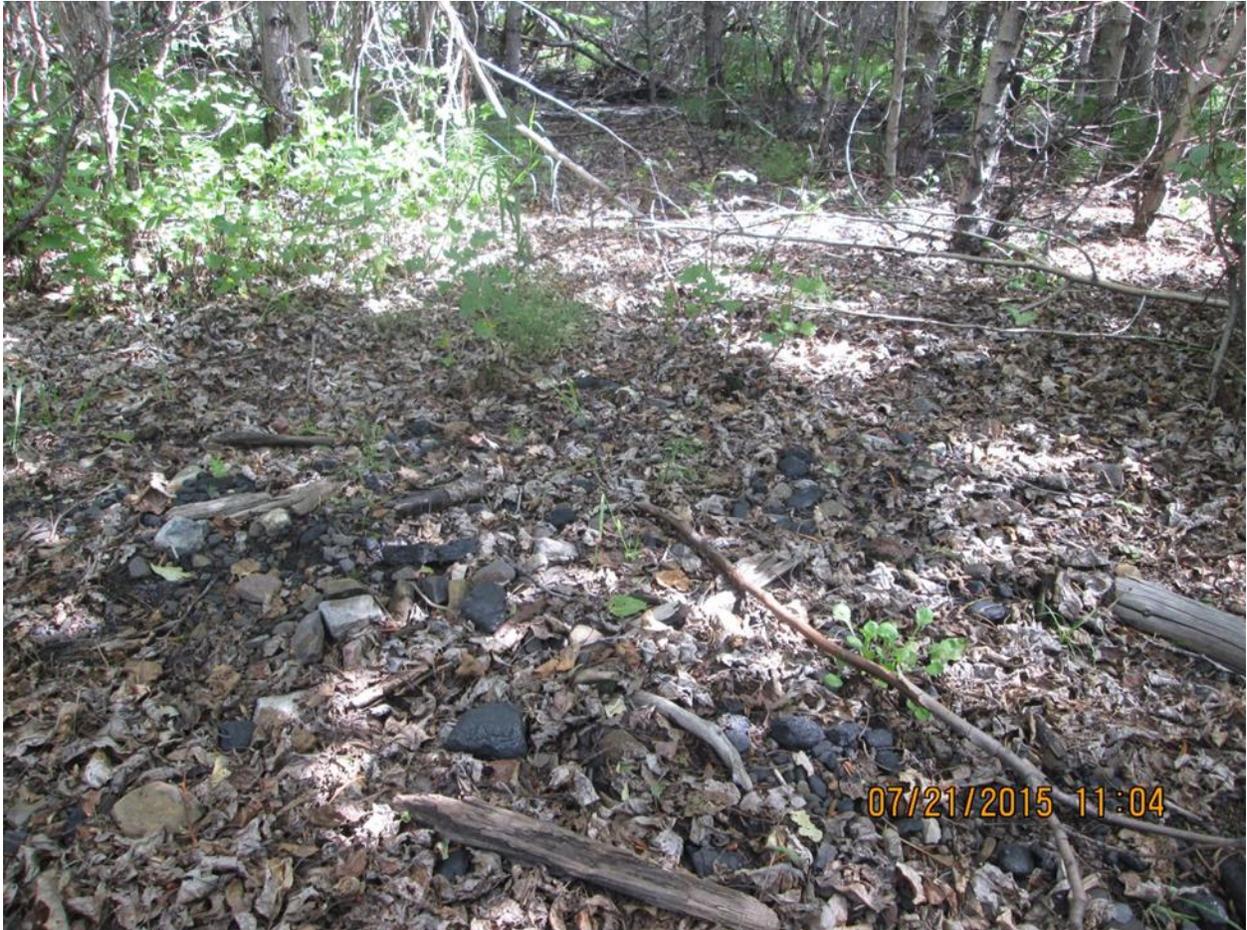
- During the visit to the site where the tributary flows into Gold Creek, it was evident by the pushed-over vegetation where the water had travelled during the July 17 rainfall and runoff. Coal deposits were clearly evident along the tributary, indicating that coal runoff from Grassy Mountain may have occurred before.⁷

Figure 4. Evidence of historical coal deposits in tributary of Gold Creek (July 2015 from AER staff)

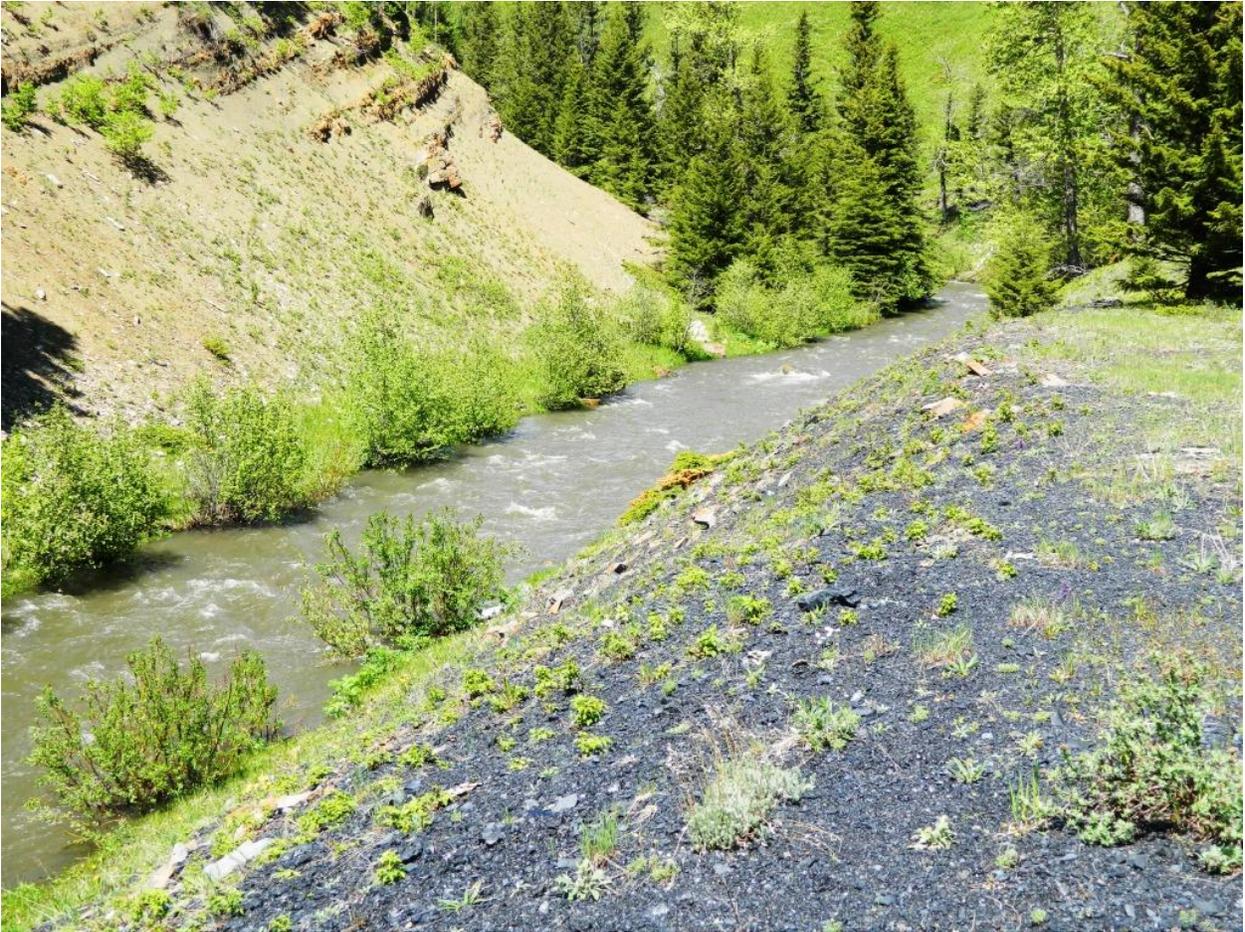
Figure 5. Gold Creek above Lillie Slack Pile (supplied by public submission)

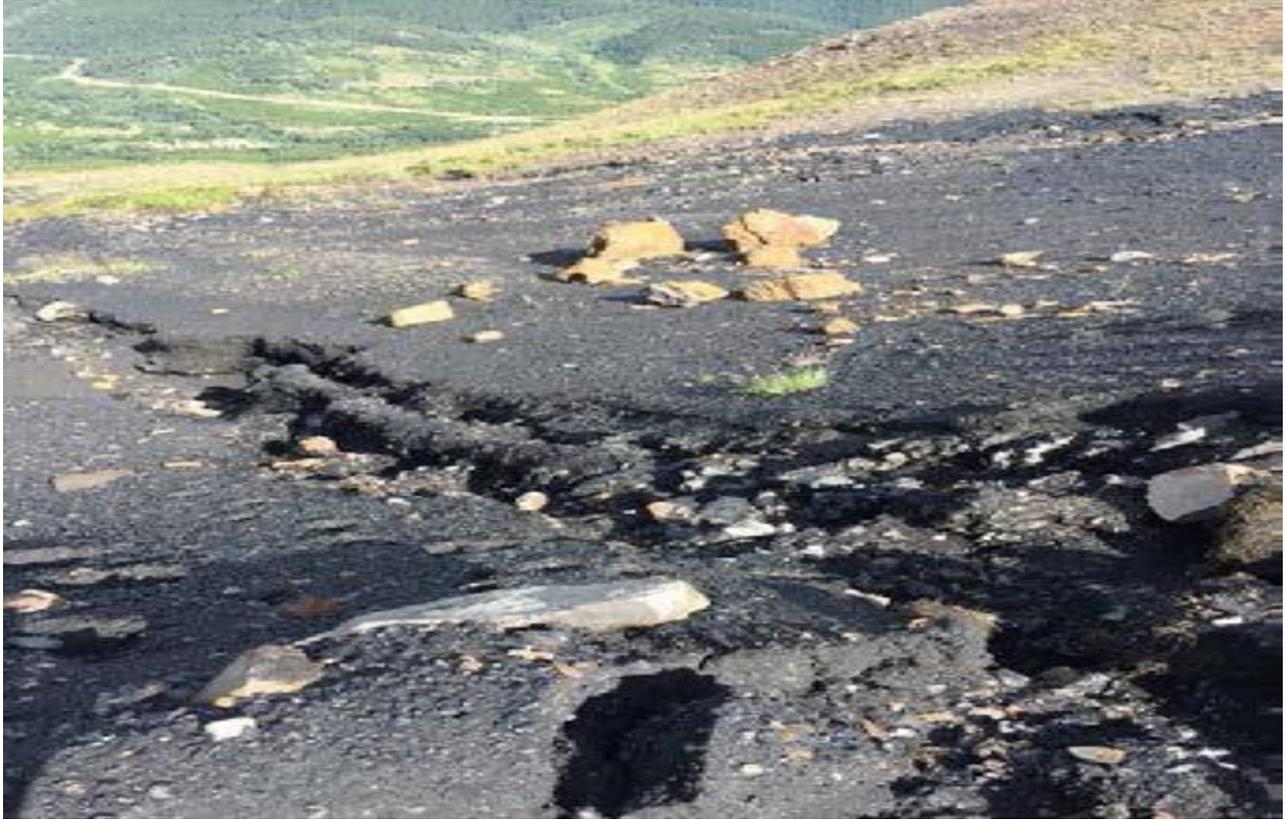
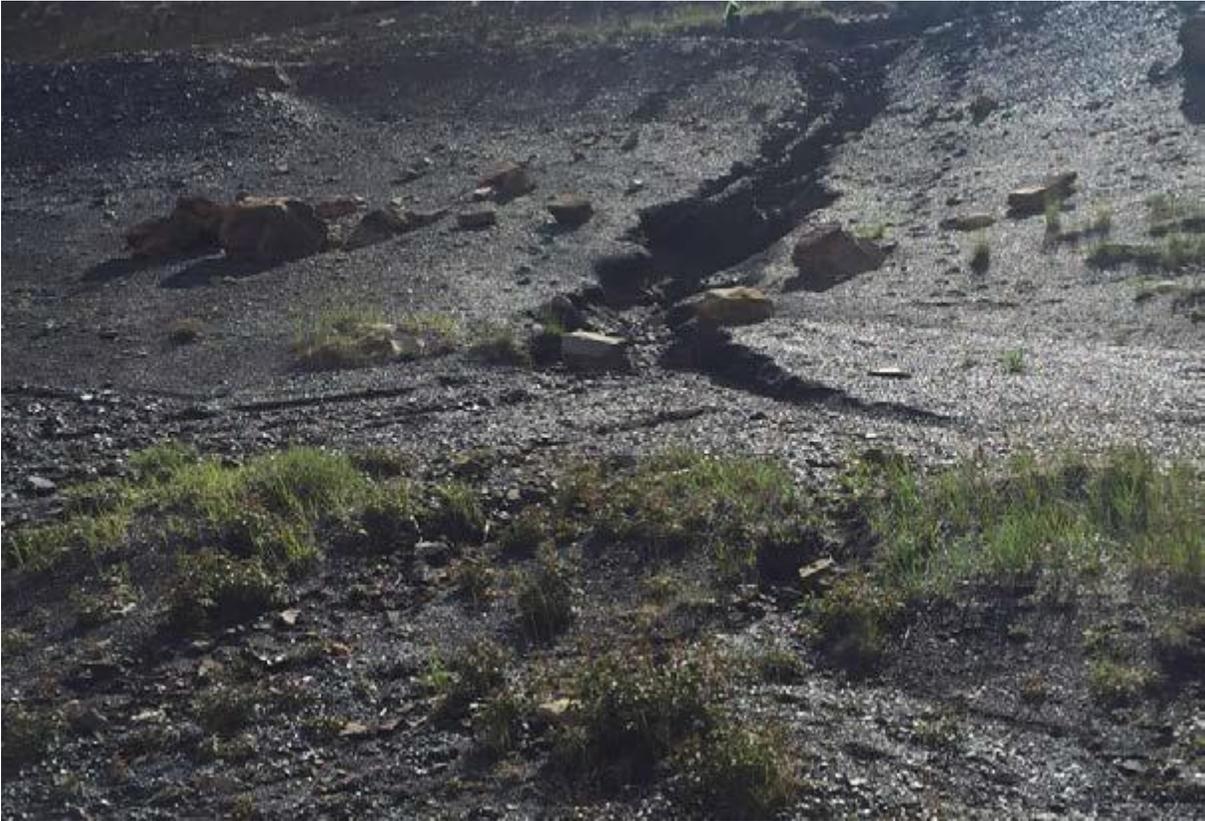
- The runoff crossed an access trail running horizontal to the mountain and perpendicular to the drainage channel in several places, cutting through a natural coal seam that lies exposed at the top of the drainage. The area in the ROE contains old slag dumps and access trails. The terrain is steep and much of the surface material is loose, unconsolidated, and easily eroded. The exposed coal seam is heavily weathered with lots of coal and coal fines at the surface. The heavy flow resulting from the rain runoff eroded the coal seam and transported coal and sediment into the drainage channel¹¹ where it followed a steep gully about 1700 m down the east slope of Grassy Mountain into Gold Creek.

Figure 6. Initial breach water after/during rain (supplied by Millennium EMS Solution)

Figure 7. Initial breach water after/during rain (supplied by Millennium EMS Solution)

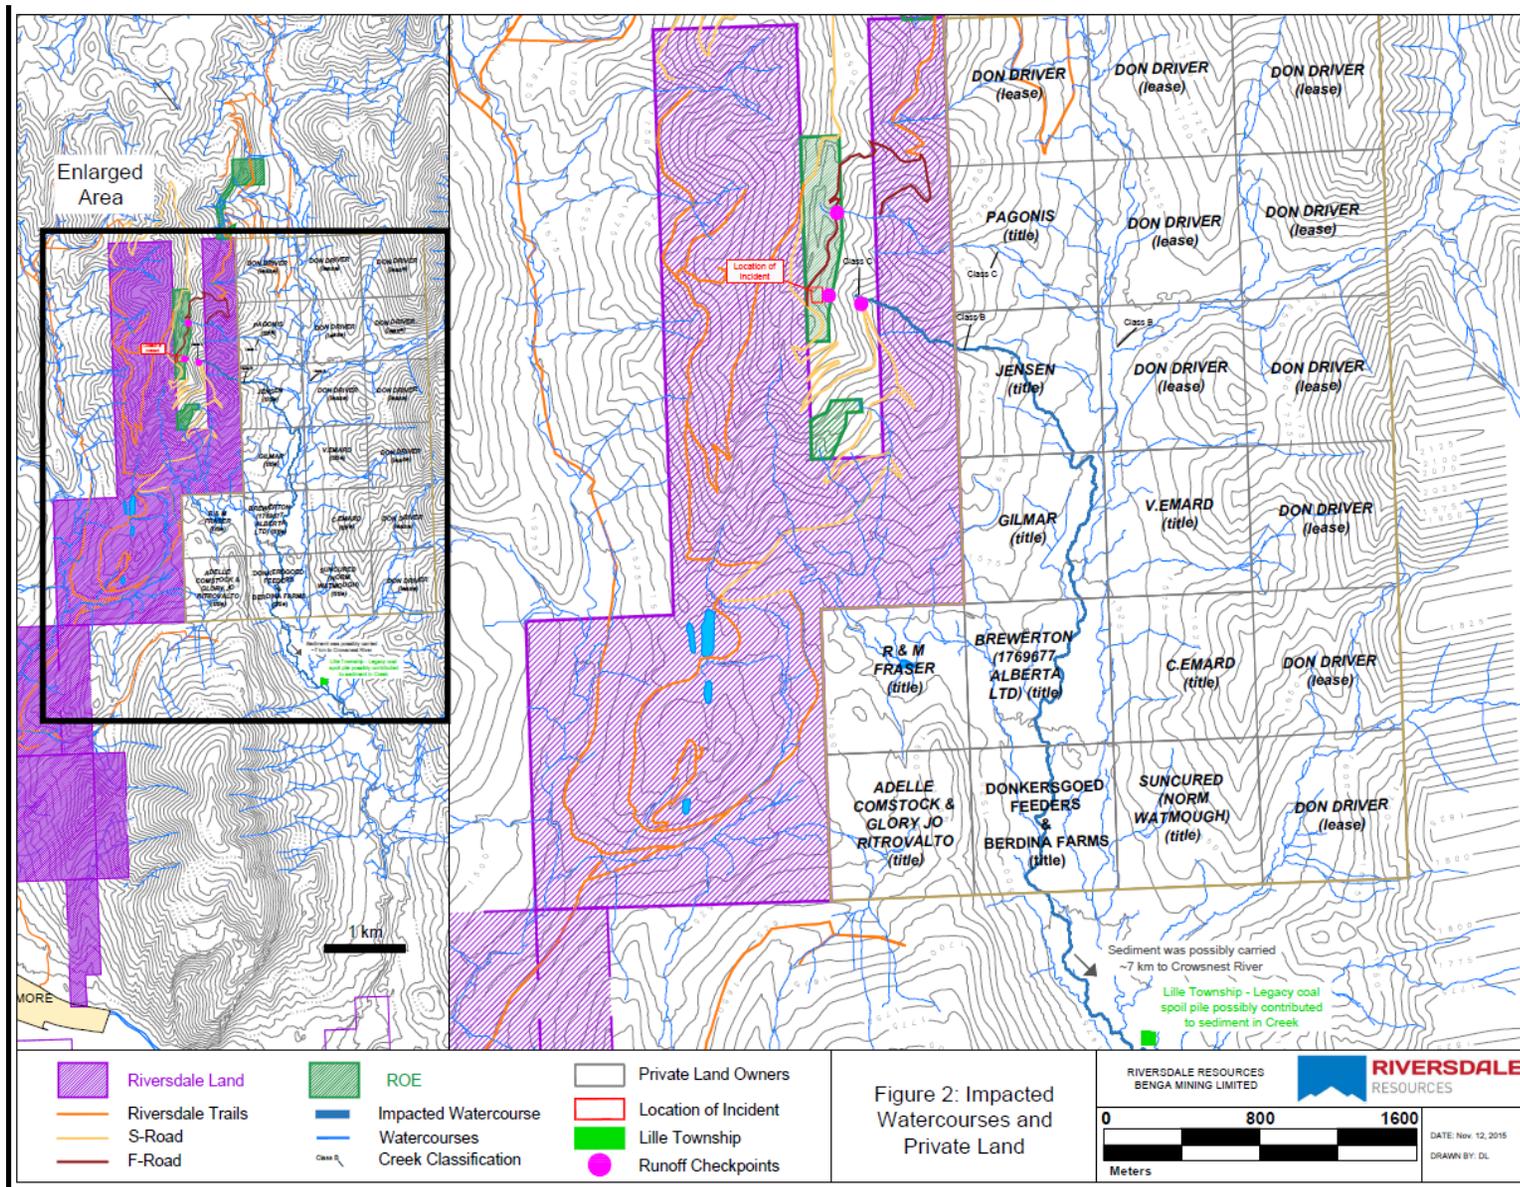
- The drainage below the coal seam passes from Crown land in ROE 8751 onto Crown land with no ROE, back onto land owned by Benga, and finally onto private (freehold) land before entering Gold Creek.¹²

Figure 8. Impacted water courses and private land (map supplied by Benga Mining)
